River restoration in Austria

Current situation | potential | case study: Morava River

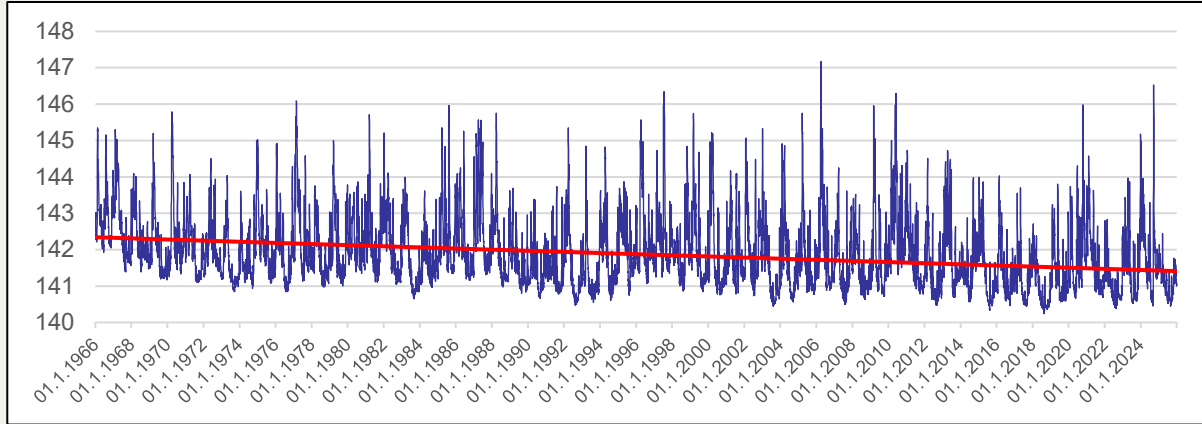
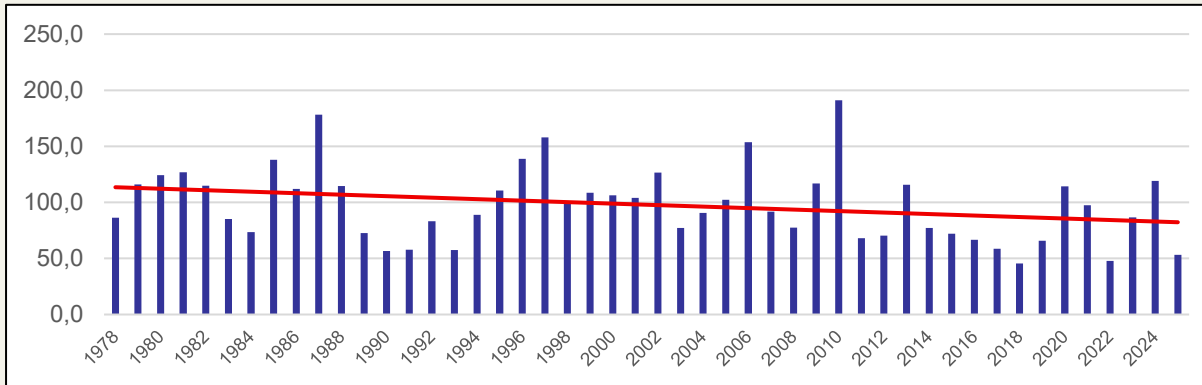
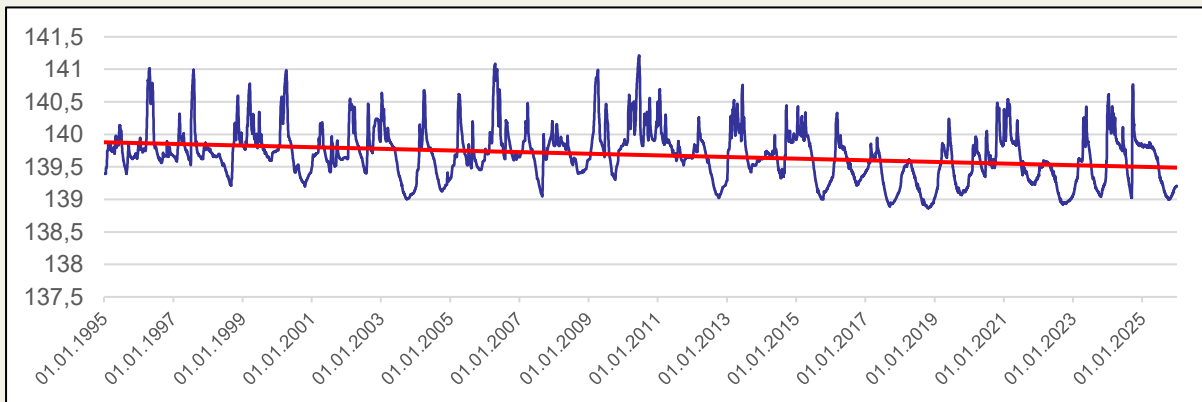
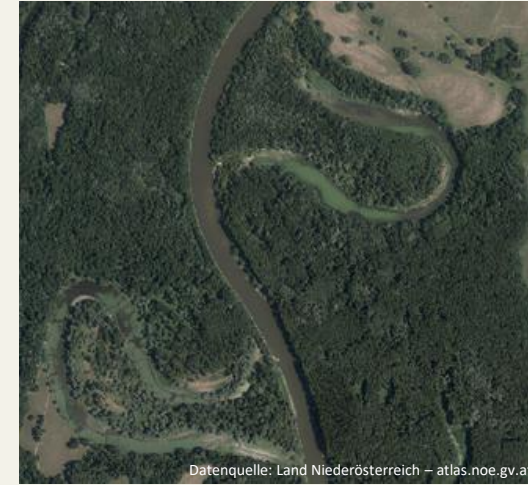
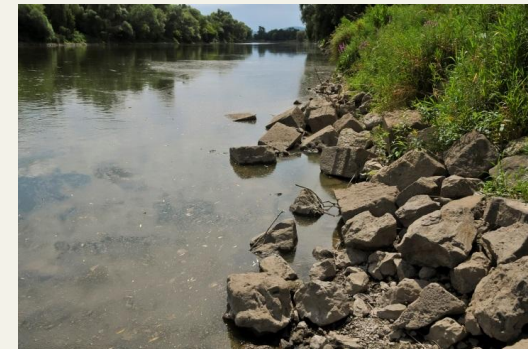
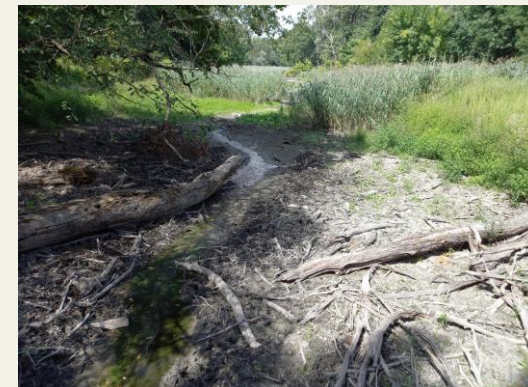
Morava: tendencies in river water level, river discharge and ground water table

Datenquelle: Land Niederösterreich – atlas.noel.gv.at

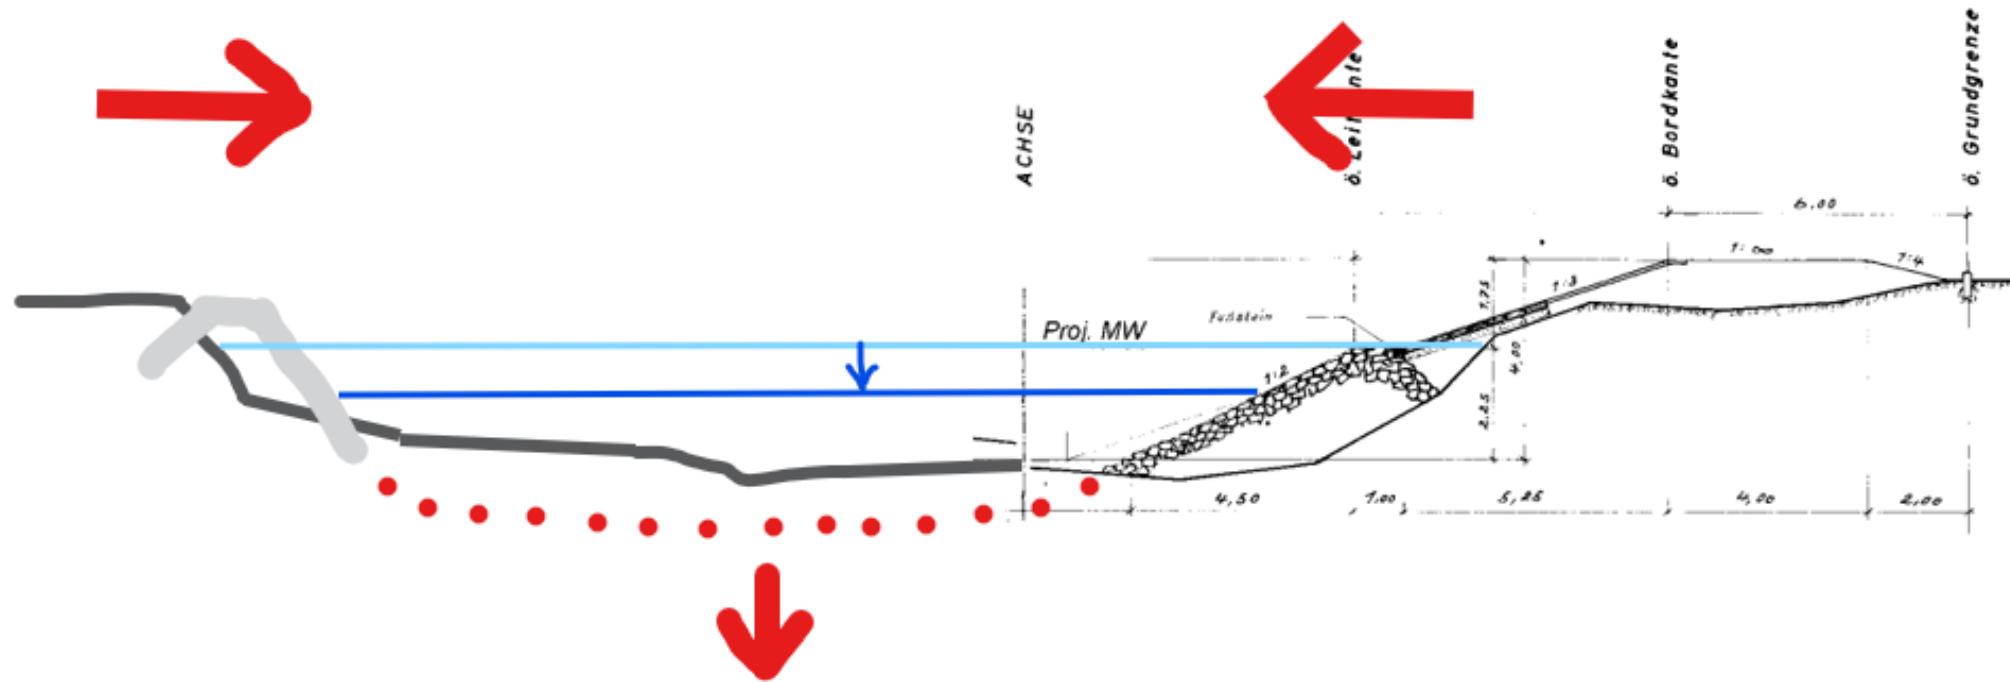
River regulation: narrowing of river bed leads to stronger soil erosion

Natural rivers: **dynamic balance between river, bank and bed**

River shorter and narrower -> water flows faster -> more erosive force

Banks artificially protected by stones -> no more bank erosion

Instead only soil erosion -> rivers digs itself into bed, water table and groundwater table fall

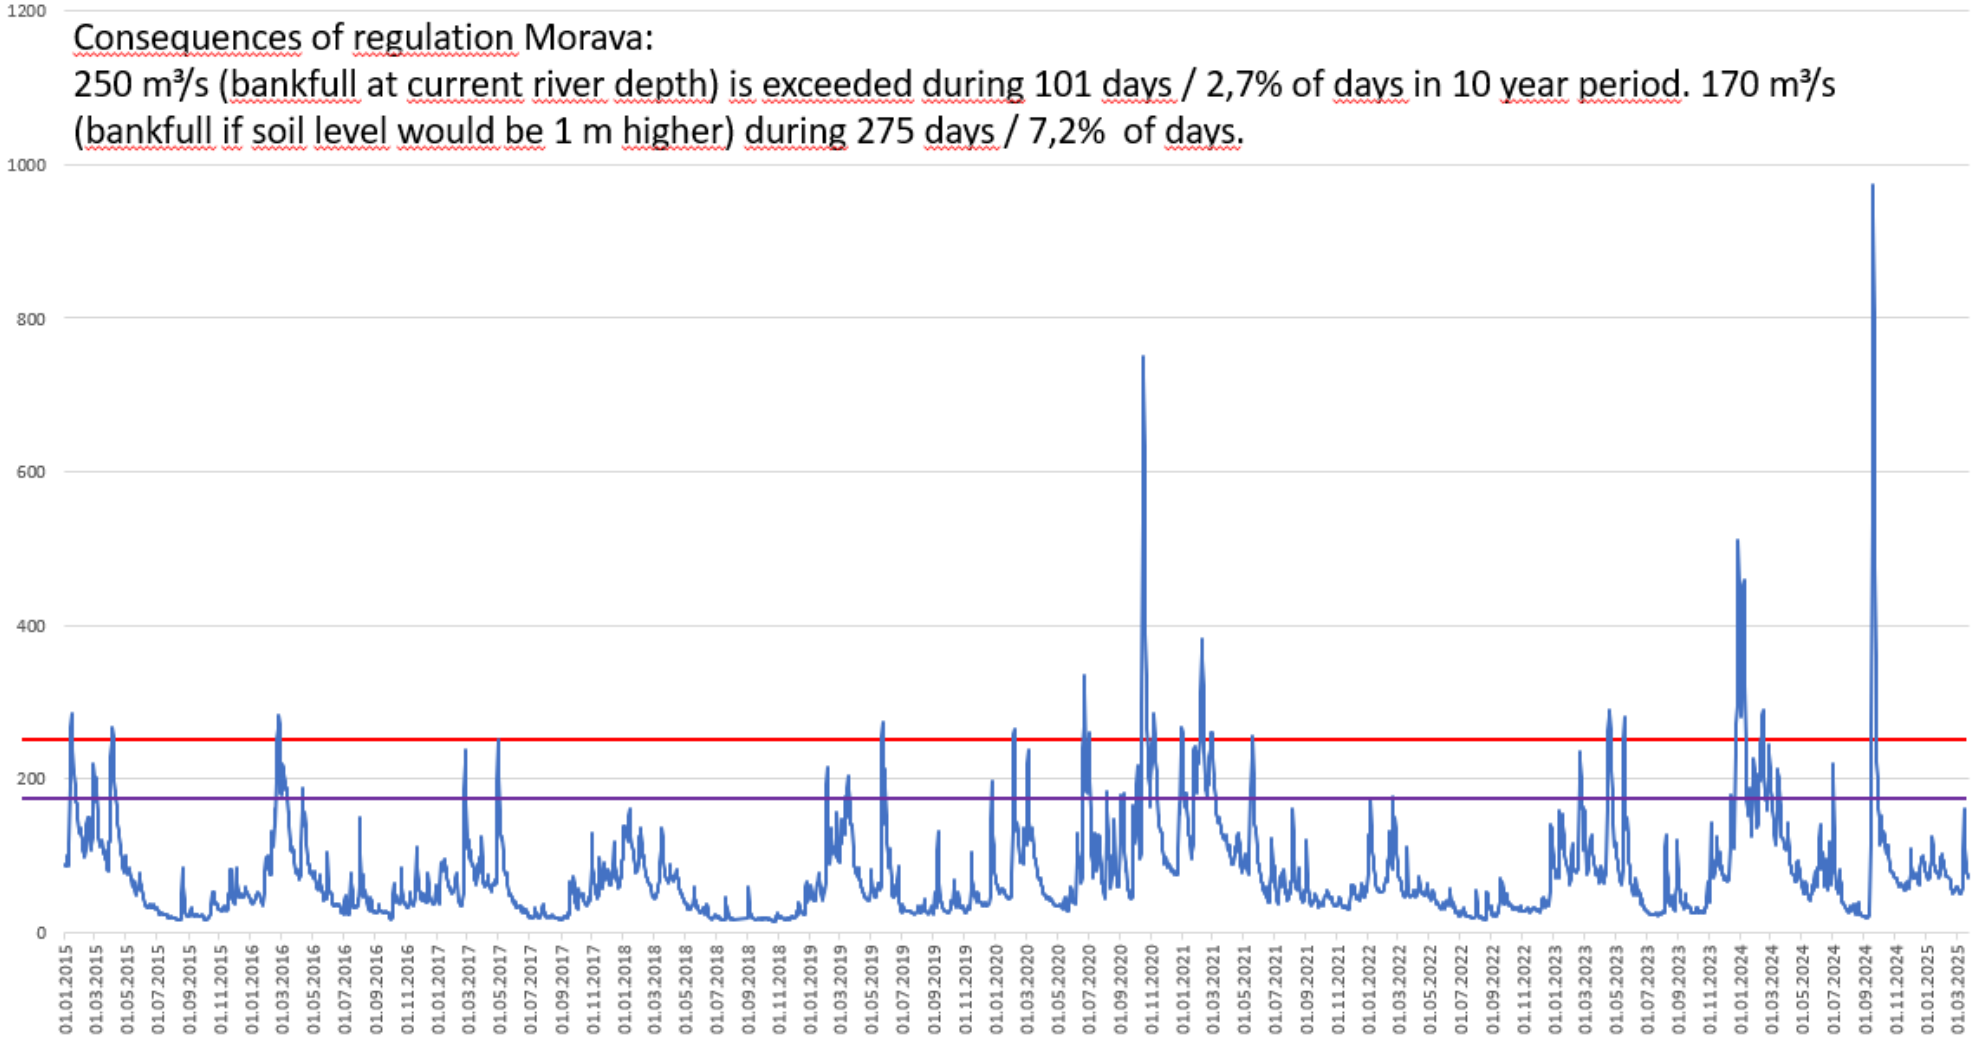
Morava: regulation during 20th century strongly reduced duration of 'bankfull events', flooding dynamics and erosive potential

Consequences of regulation Morava:

250 m³/s (bankfull at current river depth) is exceeded during 101 days / 2,7% of days in 10 year period. 170 m³/s (bankfull if soil level would be 1 m higher) during 275 days / 7,2% of days.

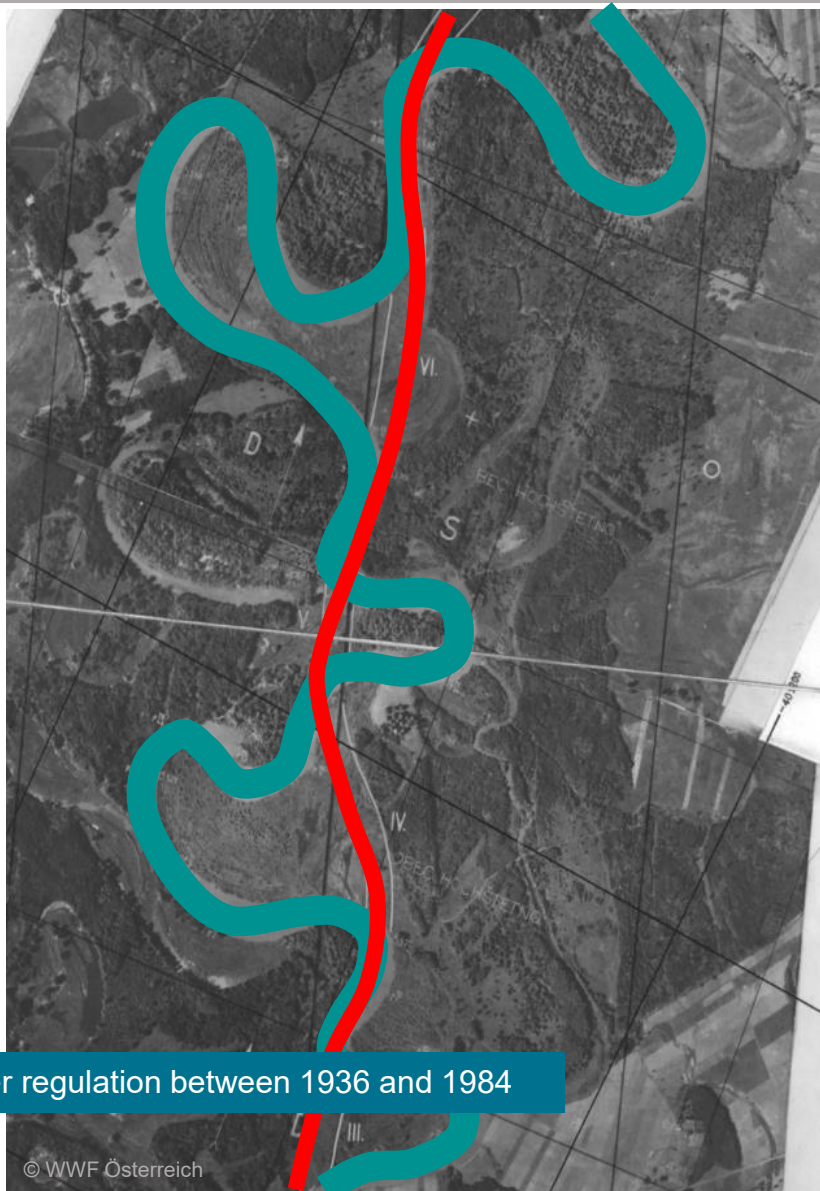
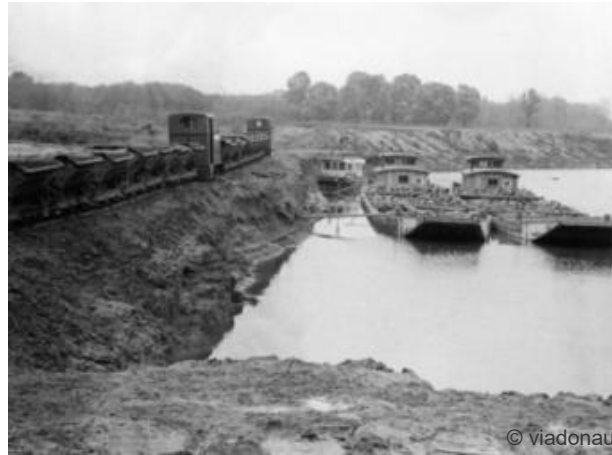
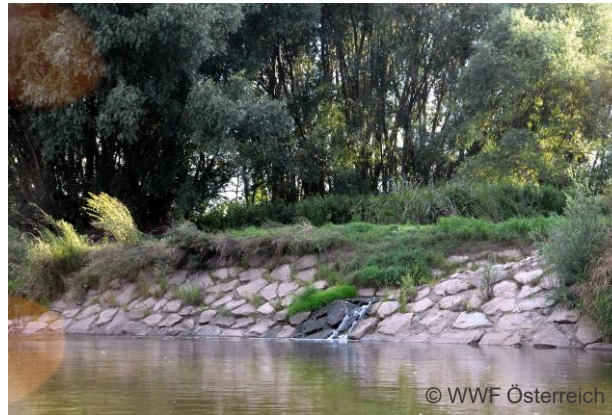
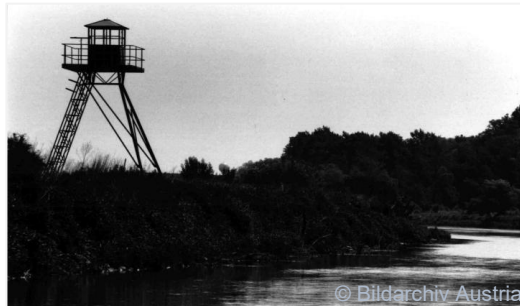
The Morava river - regulation

River regulation and dike (border reach AT-SK)

Channelization

cutting off every side arm and meander, longitudinal and transversal regulation

Straightening and shortening the river course (border AT-SK: from 80 km to 69 km)

River bank stabilization

riprap and concrete blocks on 75 % of the river bank

Regulated and standardized width of ca. 70 m (before varying between 30 and 300 m)

Flood protection dike

built between 1911 and 1967 in AT and SK (HQ₁₀₀)

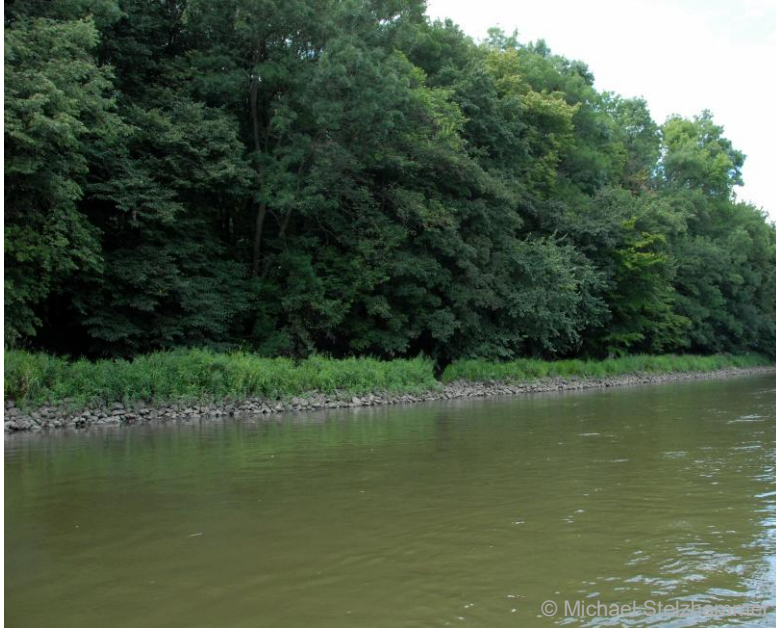
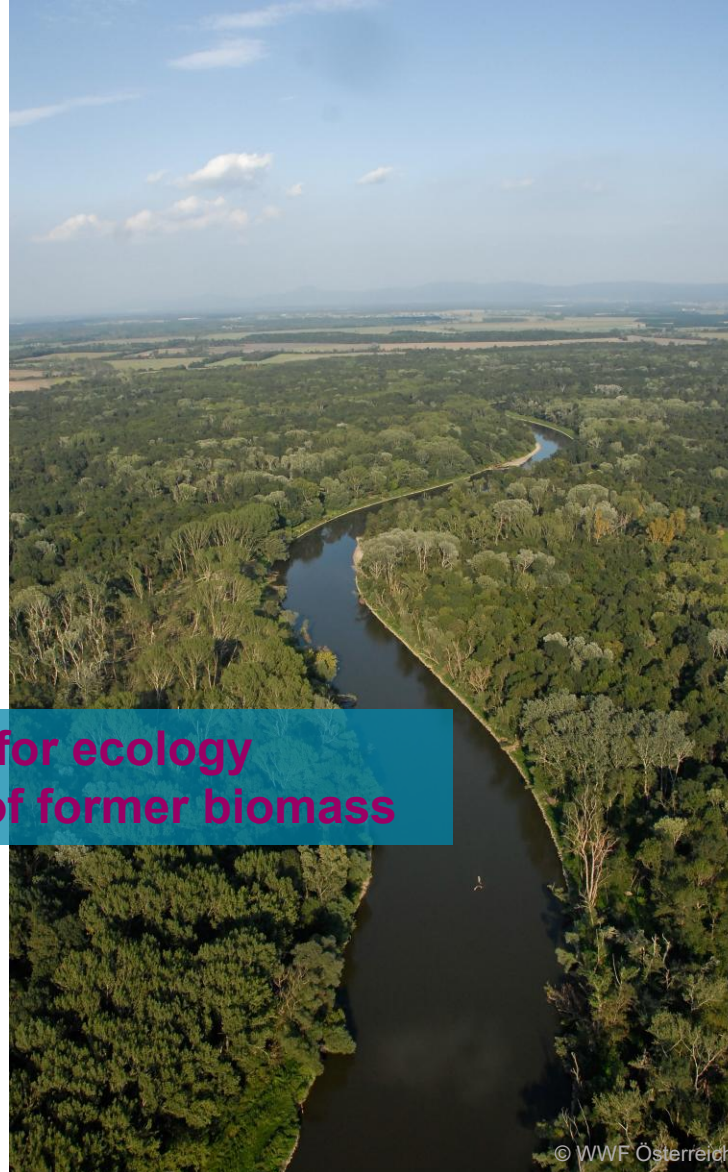
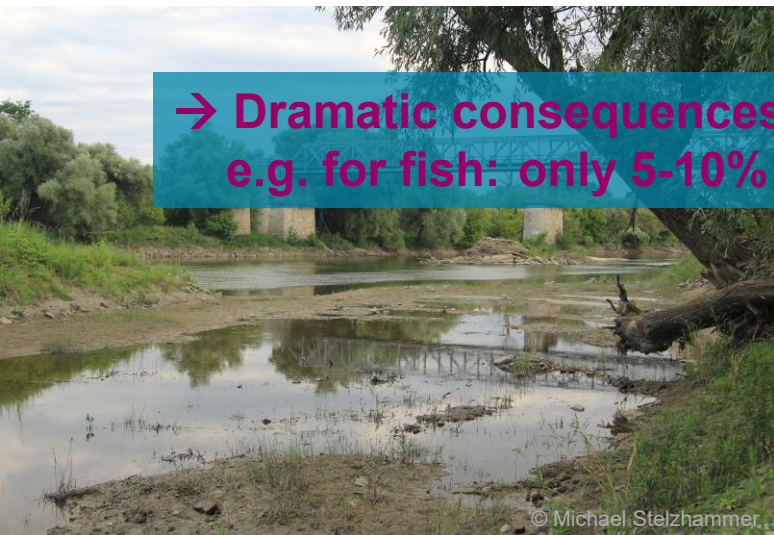
The Morava river - regulation and consequences

River regulation and dike – the consequences

Channelization

Increase in flow velocity → increase in drag force → regressive erosion river bed deepening (up to 2 m) → falling groundwater level (> 1 m)

Bank stabilization

Lateral erosion no longer possible → promotes deepening
Sediment is deposited on the bank during floods → no erosion due to bank stabilization → Decoupling of river and floodplain → Water supply to the floodplain severely restricted

Flood protection dike

Reduction of the alluvium by two thirds of the area and in width to 300 m - 3 km (previously 3-8 km!) → Floods have less space, higher waves

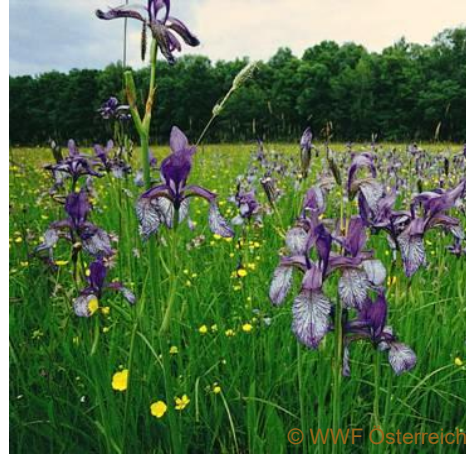
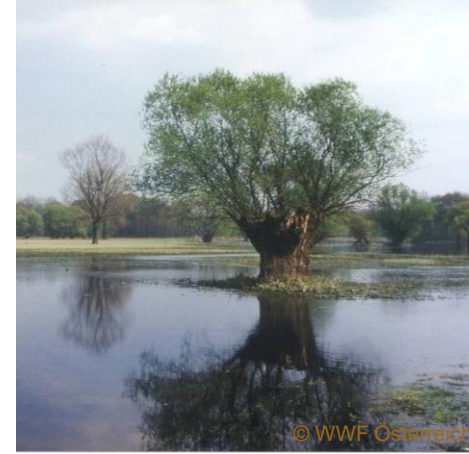
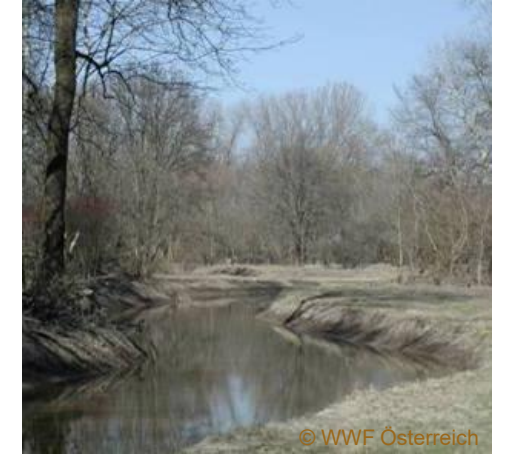
1. EU LIFE project 1995-1998

Focus on floodplain meadows (grazing)
forests (pollard willows, deadwood) and
creeks and pits, and certain species

No restoration work in / on the river

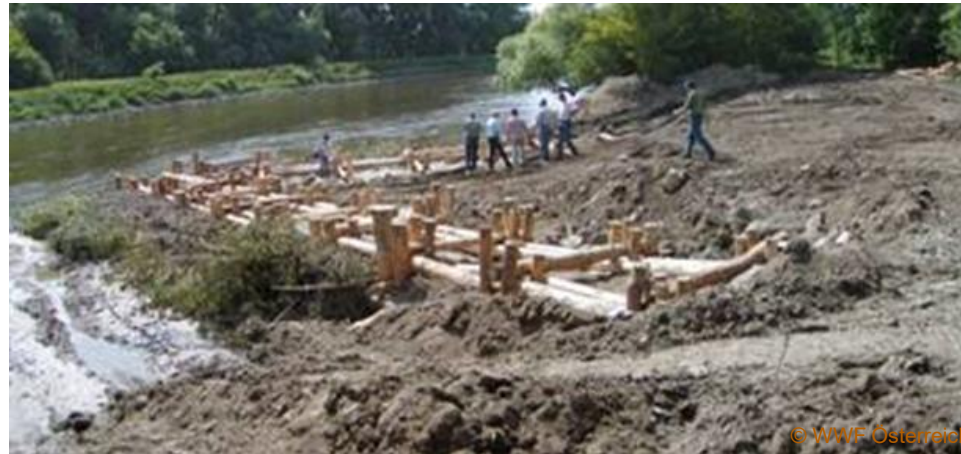
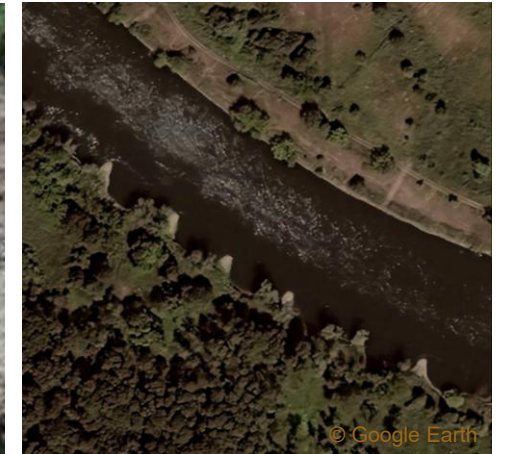
2. EU LIFE project 1998-2003

Focus on river

Re-connecting meanders, break up riparap, re-
structuring river banks (in small reaches) by
small groynes

Lessons learned:

→ just short term effects

→ too few, too small measures

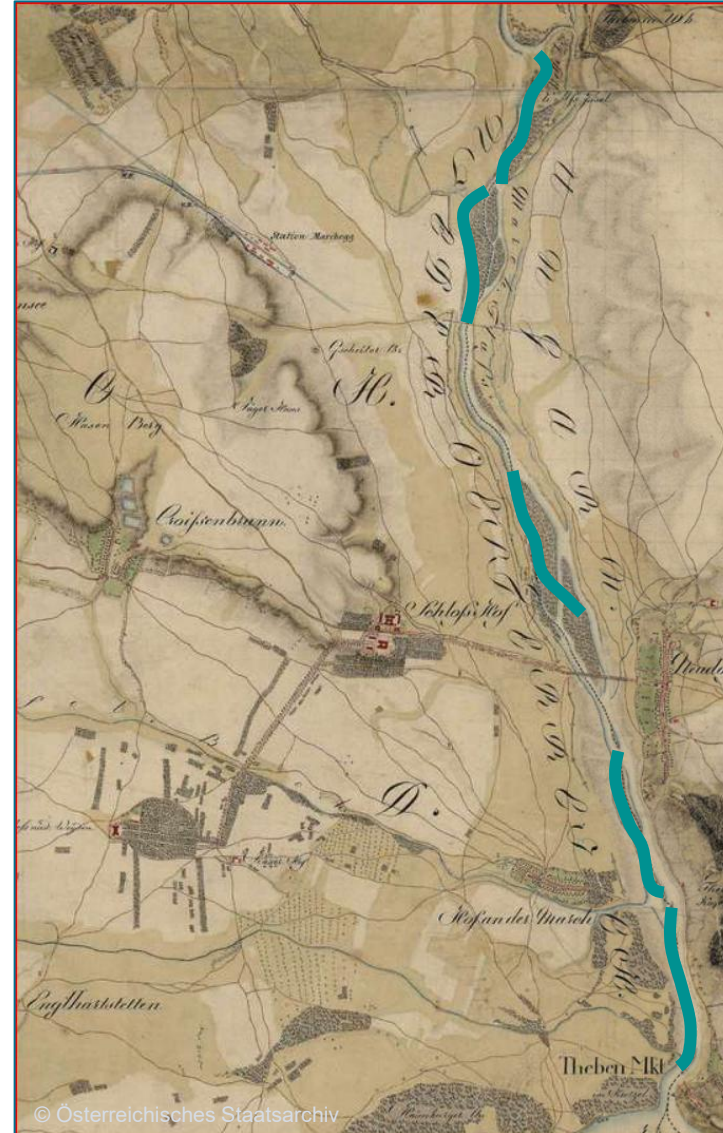
LIFE „Untere March-Auen“ – restoration old side arms

Confluence stretch

Measures

Removing 3 transversal barriers

Selective opening of bank stabilization

→ 5 new river islands

→ 1,8 km of reconnected new side arms

→ 900 m of typical tributary creek mouth

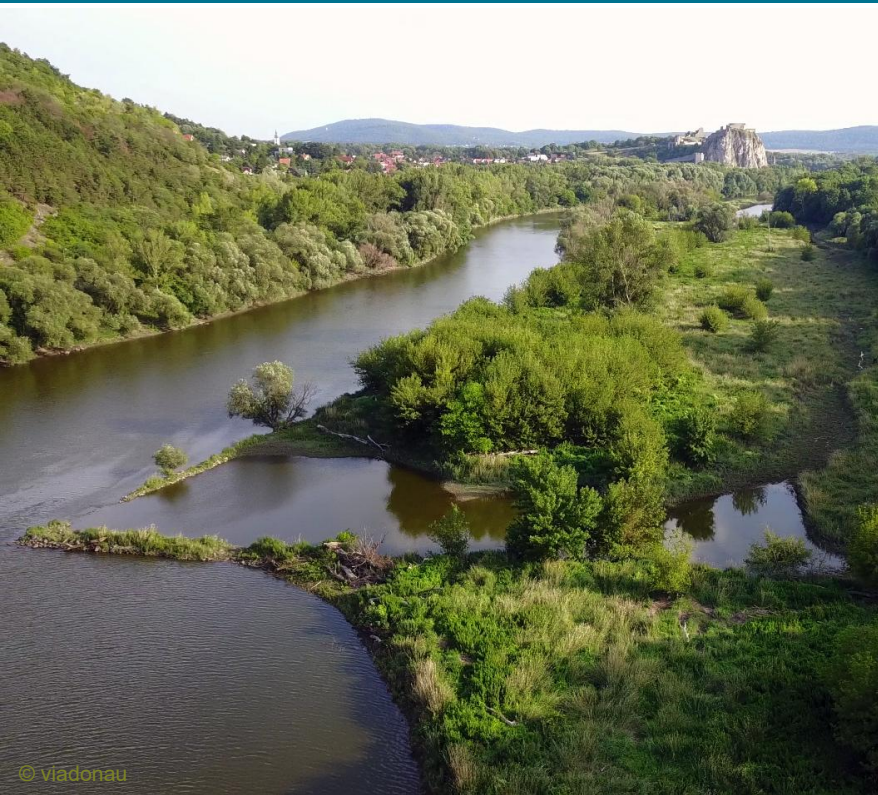
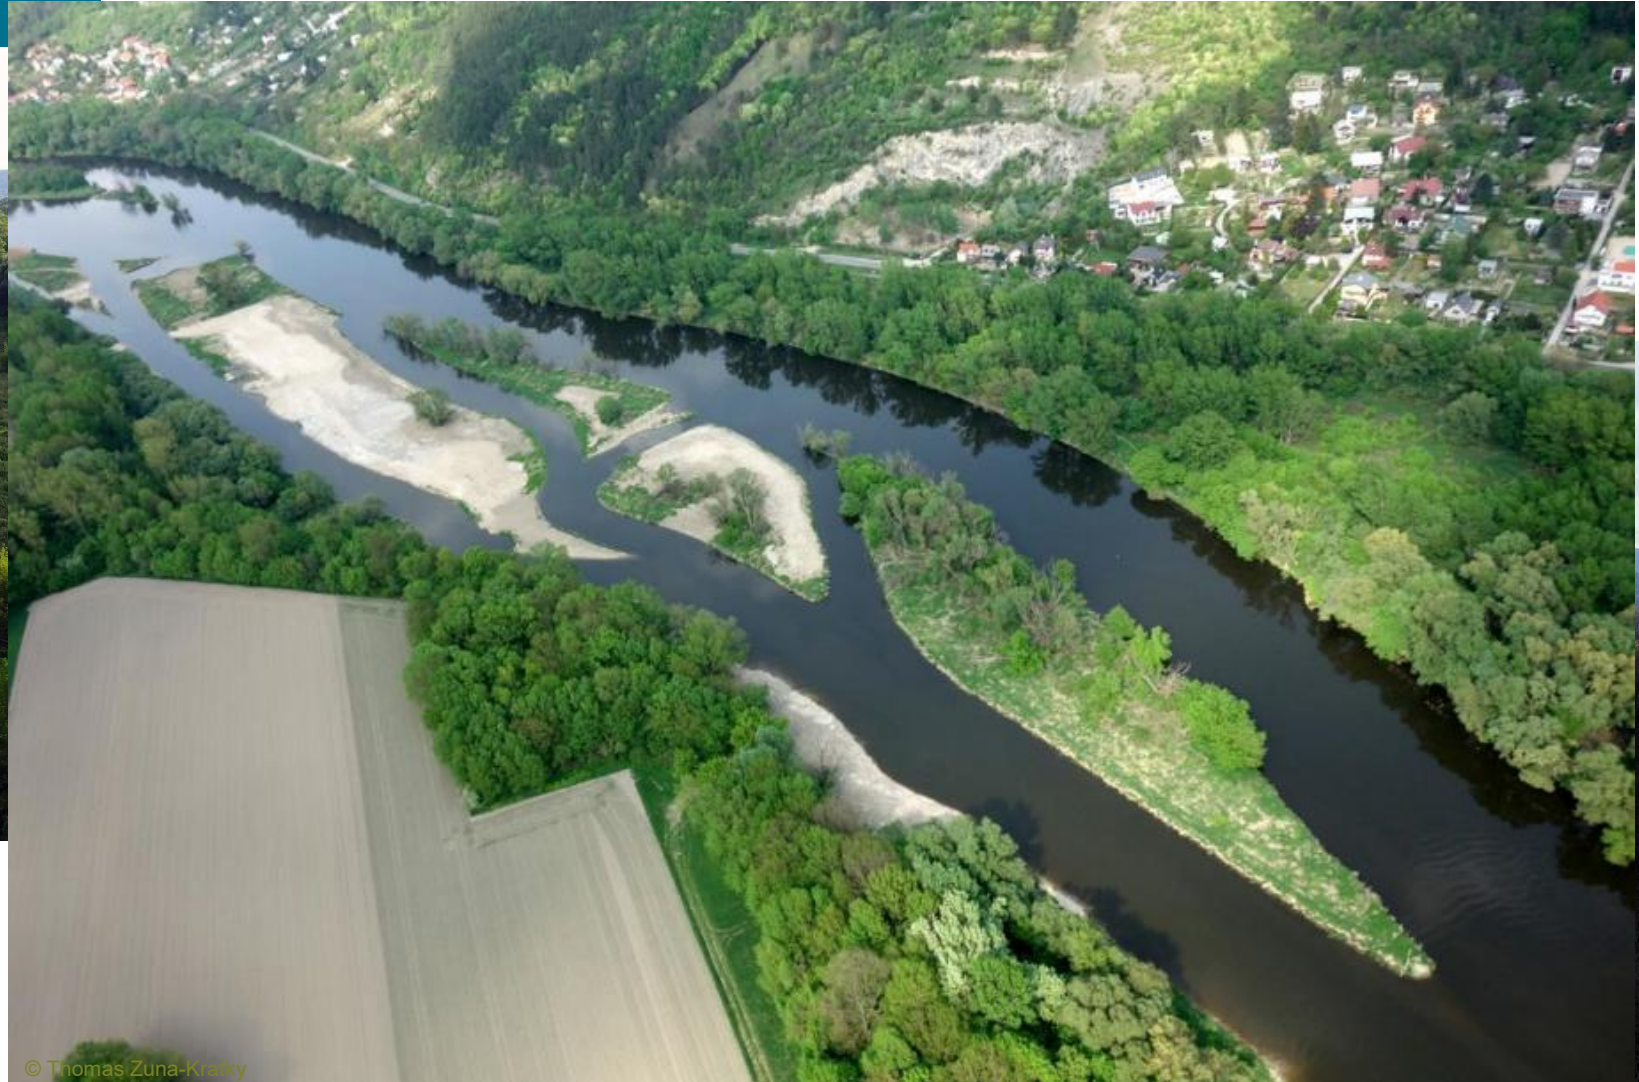
LIFE „Untere March-Auen“ – restoration old side arms

Confluence stretch

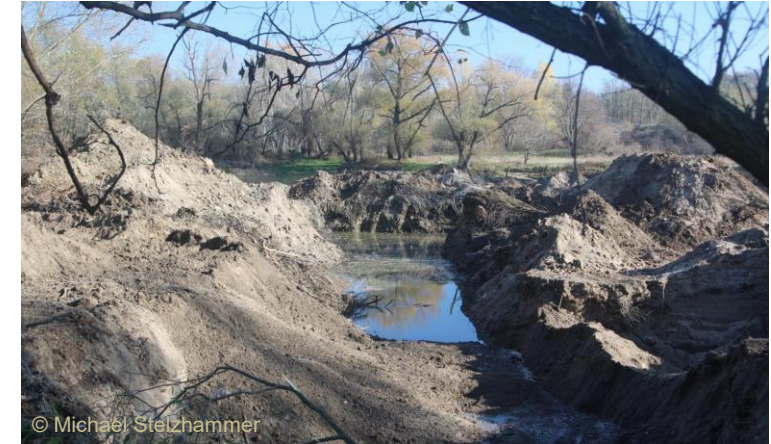
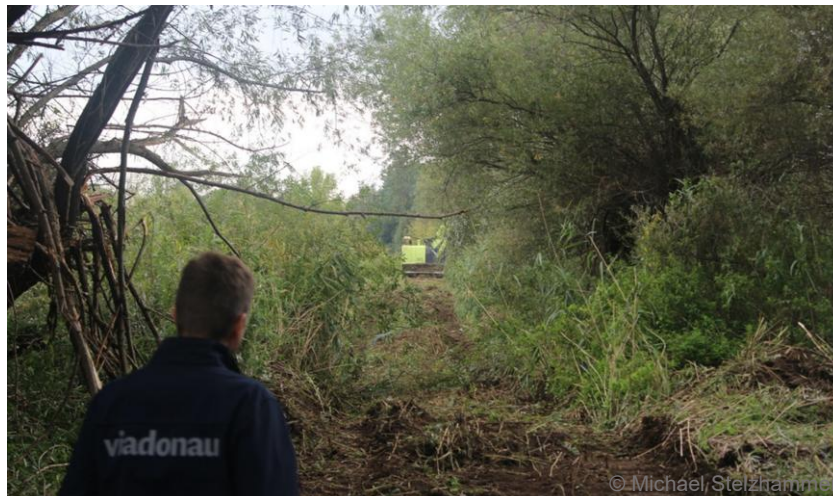
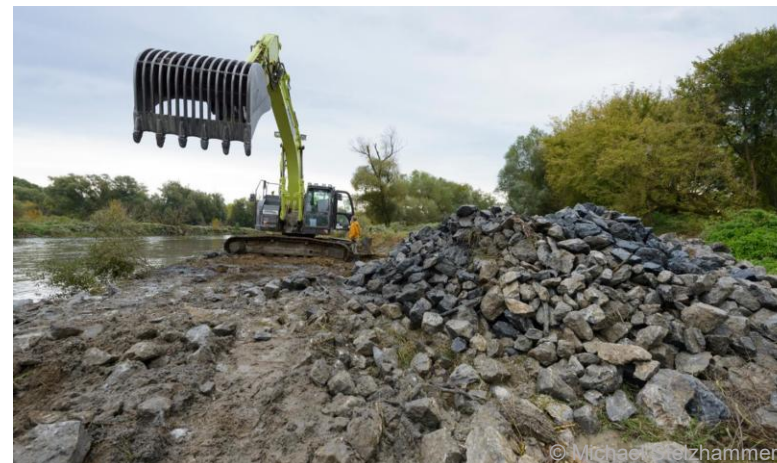
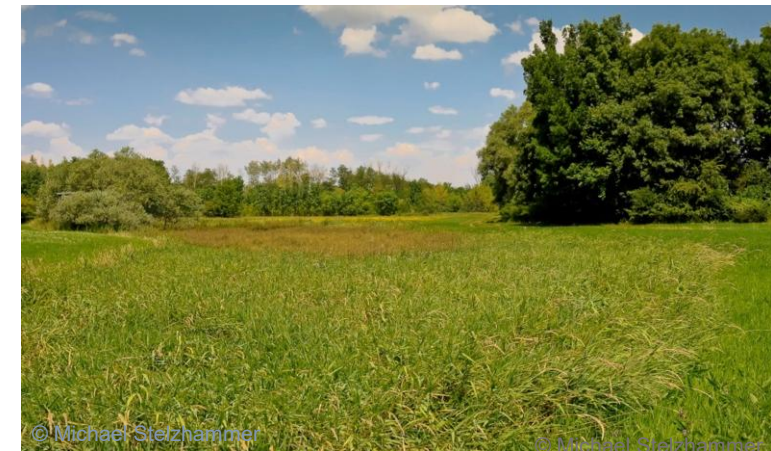
LIFE „Untere March-Auen“ – restoration old side arms

“Wolfsseeinsel” side arms

Measures

Re-digging of two completely silted-up former side arms (6 m width; initial ditches)

Removing 3 transversal barriers

→ 1,2 km of reconnected side arms

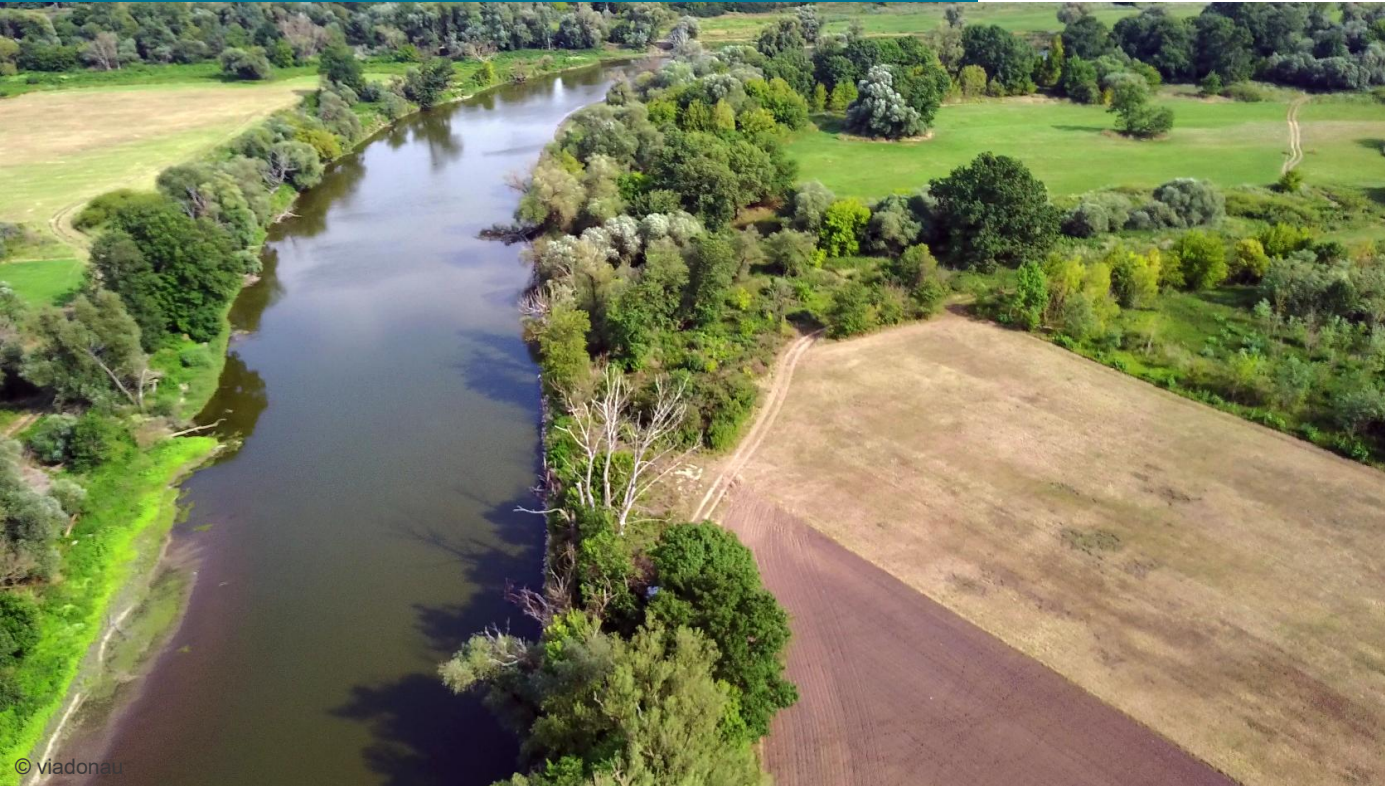
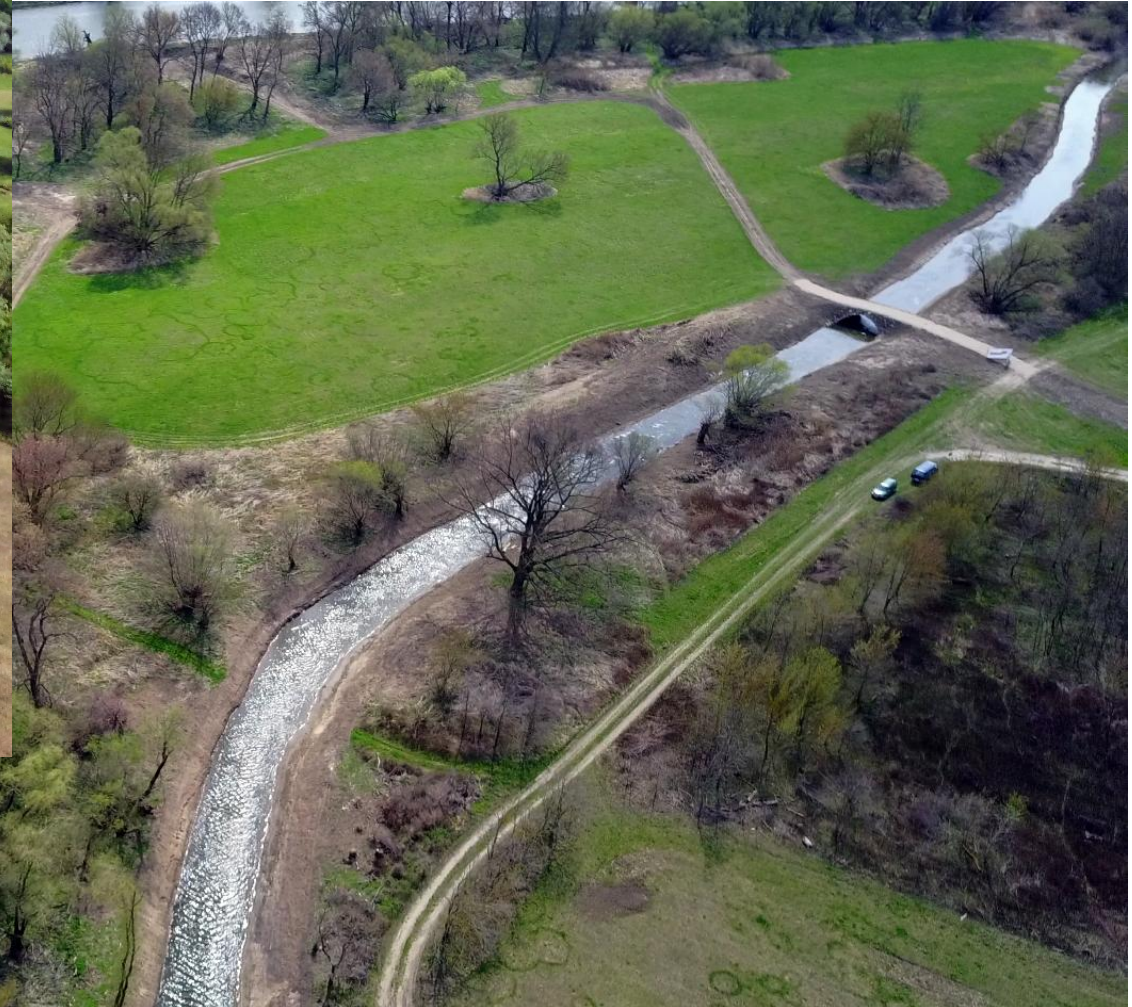
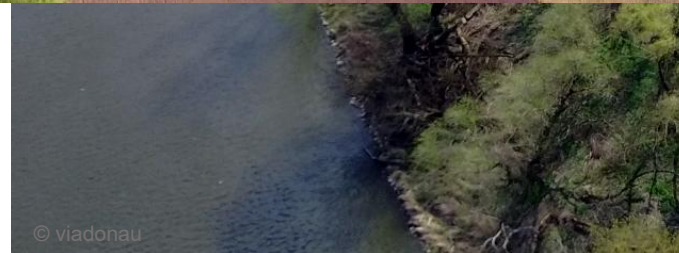
LIFE „Untere March-Auen“ – restoration old side-arms

“Wolfsseeinsel” side arms

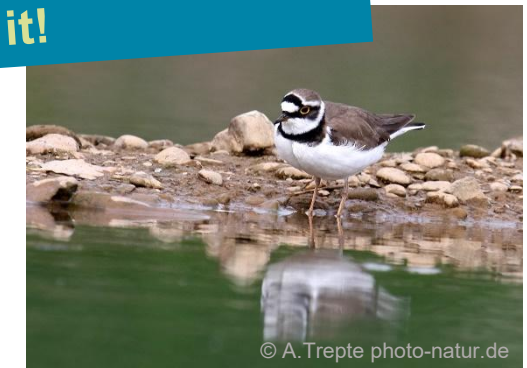
The sandbanks in the side arms are colonized by **little ringed plovers** and **sandpipers**.

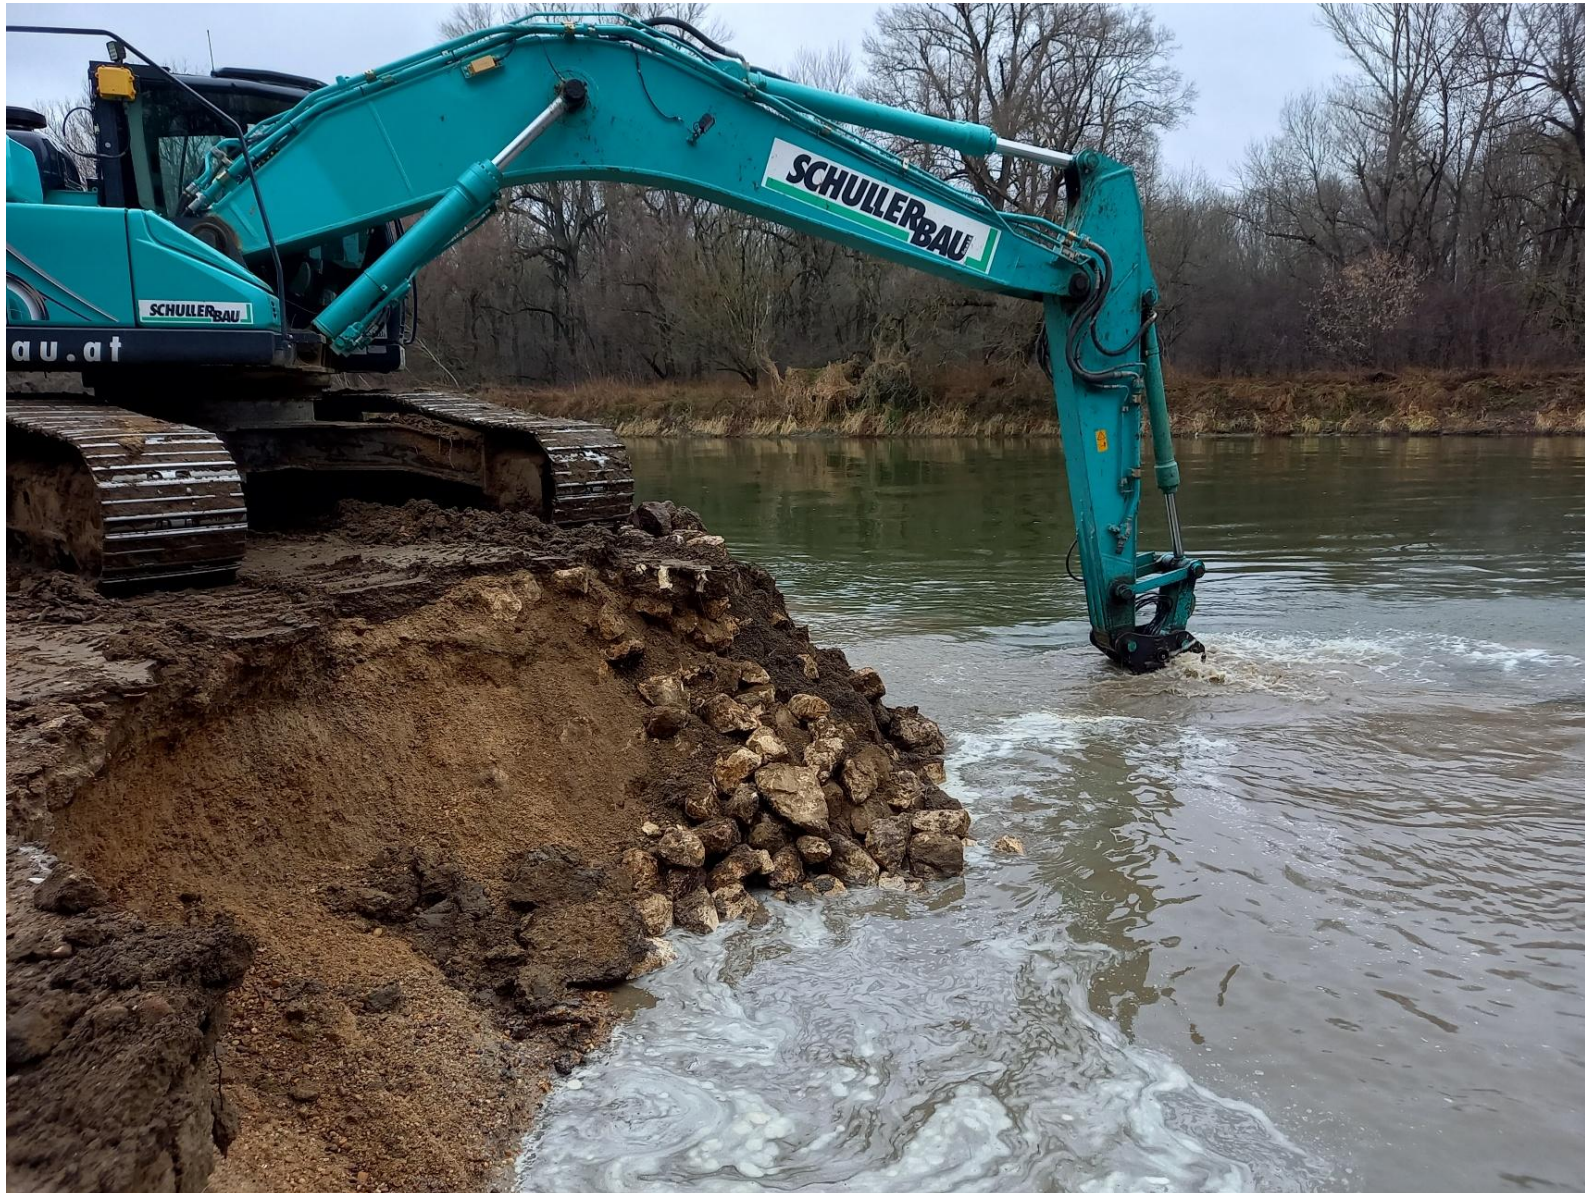
Next project (viadonau, 2022): 700 m natural bank restoration.
Removal of stones (riprap), appr. 5-10 m³ per m bank length

Important lesson: bank erosion and restoration of natural dynamic situation go very slowly! All stones must be removed, especially at the river bottom. Otherwise hardly any dynamics.

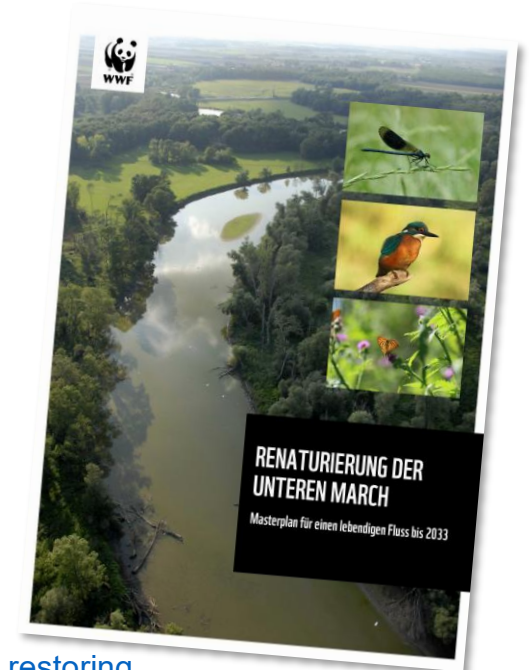
[Masterplan for restoring the Lower Morava River](#) © WWF Austria, riocom.at

Plan for the Lower Morava:

Removal of bank stabilization where ever possible

Pilot site WWF floodplain reserve in Marchegg

- 12 km riprap removal
- Initiating new meandering (instead of re-connecting old meanders)
